## Technical Report

Report No **R13372**  
Author **M Swanborough**  
Date **01 July 2013**

Face Fix Restrictor

BS EN 13126-5:2011

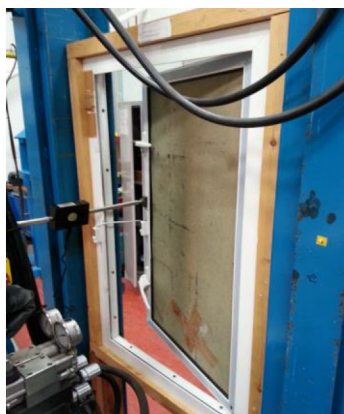
The test sample mounted on the side hung window provided was fitted into the security test rig. The test rig operating equipment was adjusted to test in accordance with clause 7.4 as per BS EN 13126-5-2011. The Following loads are applied without shock for 60 seconds to the window sash in the direction opening.

200N for 60 seconds  
350N for 60 seconds  
500N for 60 seconds

**Mechanical loading**

The Restrictor showed no obvious signs of wear after completion of the above testing. It continued to operate normally after the test and therefore met the requirements for a Pass as specified in clause 7.4 as per BS EN 13126-5-2011

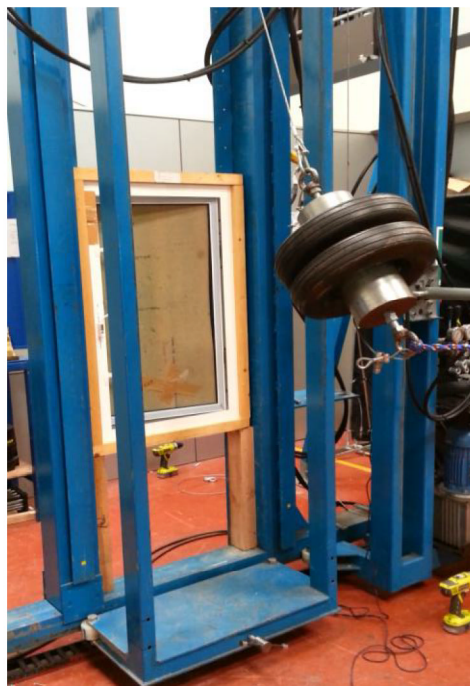
The Restrictor fitted to a window sample should withstand a mass colliding with the active sash to one or more of the grades specified below as per EN 13049. A 50kg double tyre impactor was dropped from the required grades drop height and impacts the centre of the window sash.

- Grade 1 - 200mm
- Grade 2 - 300mm
- Grade 3 - 450mm
- Grade 4 - 700mm
- Grade 5 - 950mm

Grade 1 Drop height

The Restrictor achieved a pass at Grade 1. This test has been video recorded for review if required. The restrictor remained engaged and continued to operate normally after the test and therefore met the requirements for Grade 1 as per clause 7.7 specified in BS EN 13126-5-2011

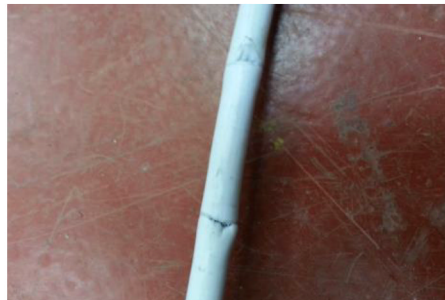
The Restrictor showed cord showed some signs of wear after completion of the test however these were minimal (photo below). This test has been video recorded for review. The restrictor continued to operate normally after the test and therefore met the requirements for clause 7.8 as specified in BS EN 13126-5:2011

Restrictor cord after testing
