Test Report : Chilt/IF04007

**A fire resistance test performed on
a penetration sealing system fitted
within a blockwork floor slab**

**Test conducted in accordance with the general
principles of BS 476: Parts 20 and 22: 1987**

Test for :
Tenmat Ltd
Ashburton Road West
Trafford Park
Manchester
M17 1RU

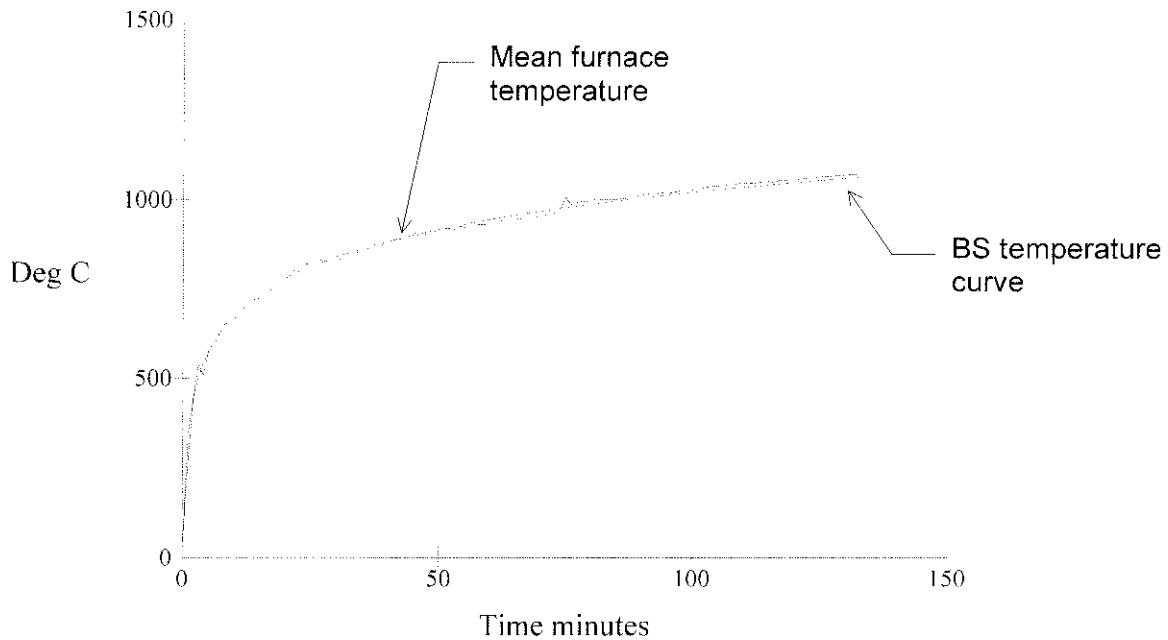
7.1 Furnace temperature curve

- 3.4 The furnace was controlled to follow the temperature/time relationship specified in BS 476: Part 20: 1987 as closely as possible, using the average of four thermocouples suitably distributed within the furnace on the vertical plane. The temperatures recorded are shown graphically in Section 7.1.

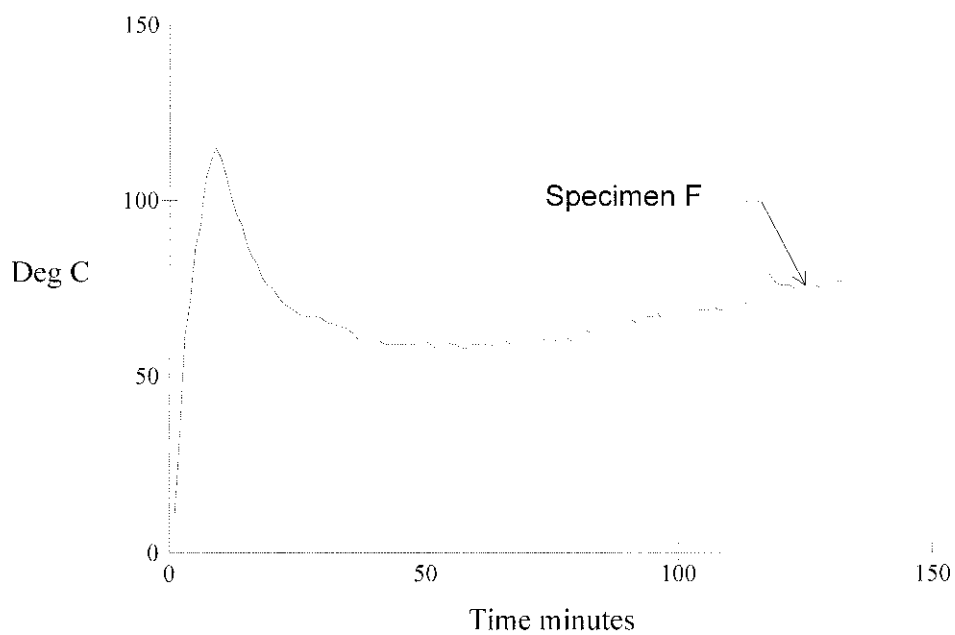
7.2 Unexposed face temperature curve of specimen F

- 3.5 The temperature of the unexposed surface of the duct was monitored by means of a thermocouple fixed to the surface of the duct, 25mm from the unexposed face of the slab and a thermocouple fixed on the surface of the slab 25mm from the duct. The temperature of the duct is shown graphically in Section 7.2.

Maximum temperatures of duct

Insulation	Integrity
Specimen F	133 (one hundred and thirty three) minutes*	133 (one hundred and thirty three) minutes

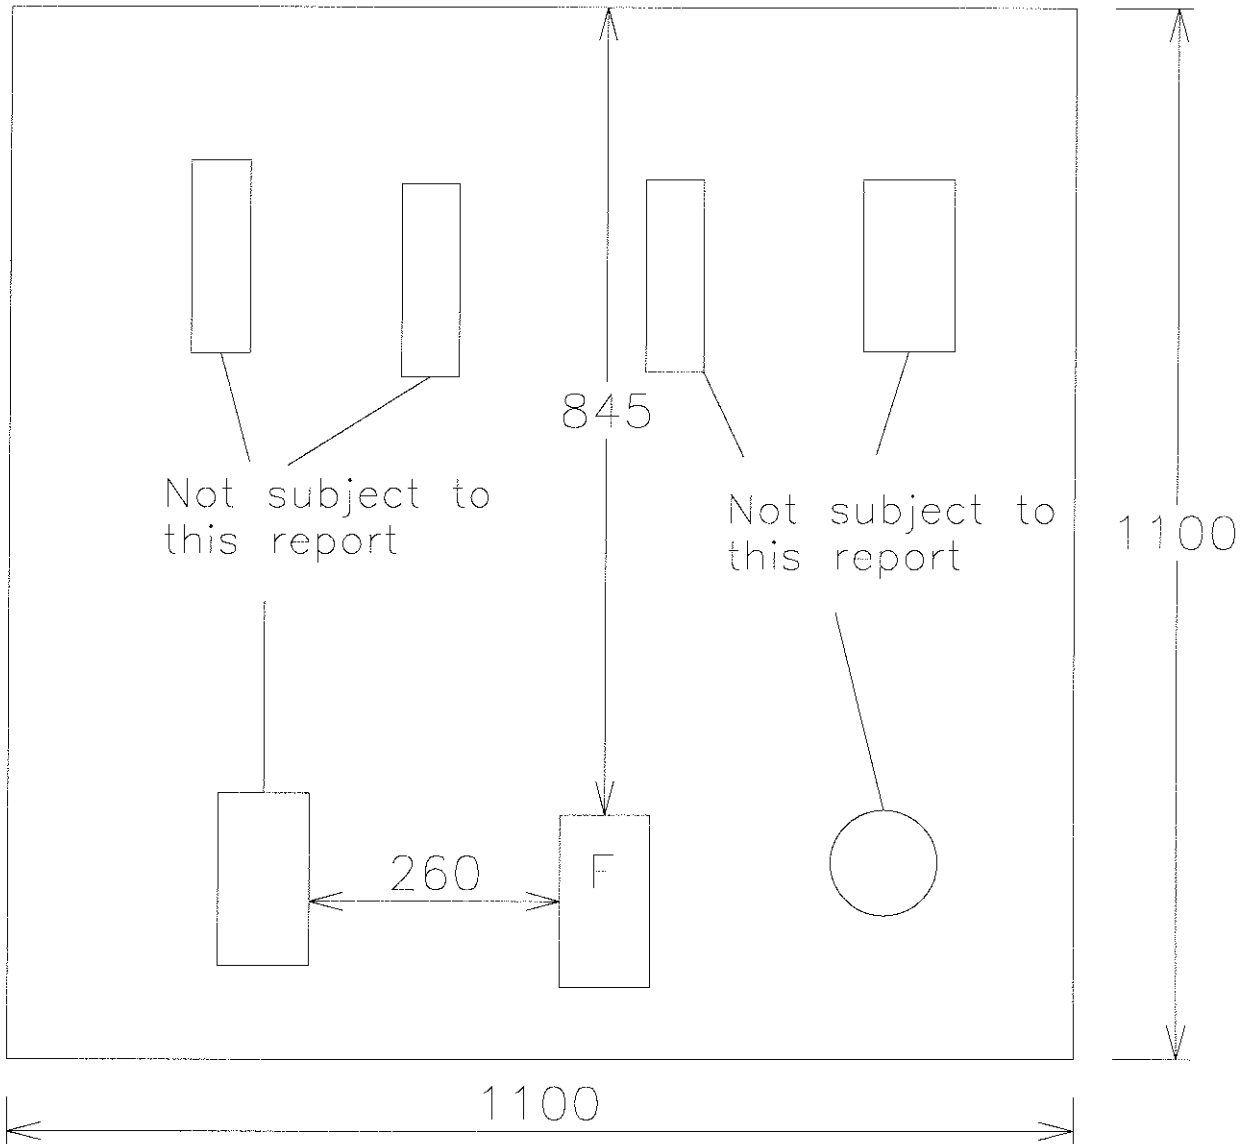
Specimen F was a 1100mm long, 180mm deep x 95mm wide PVC duct with a 1.7mm thick wall. The pipe was fitted within the block work slab so that 500mm of the duct was protruding on the unexposed face. The duct was located 845mm from the rear of the furnace and 570mm from the left. A Tenmat FF101M 8mm intumescent sleeve was fitted around the duct, centrally within the block work slab.

Title Unexposed face of block work slab showing penetration locations
(All dimensions in mm)
